# REPLACEMENT RESERVE STUDY REPORT – FY 2024

## YOUR CONDOMINIUM

September 30, 2023

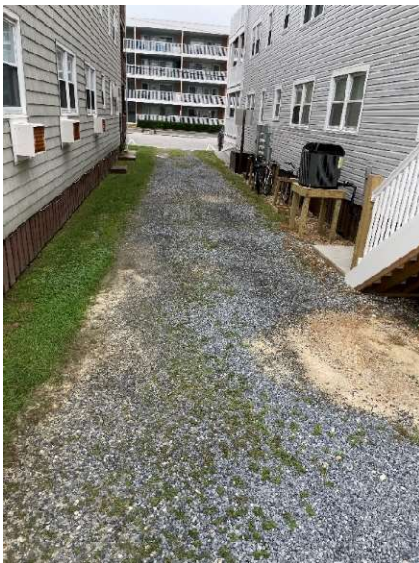
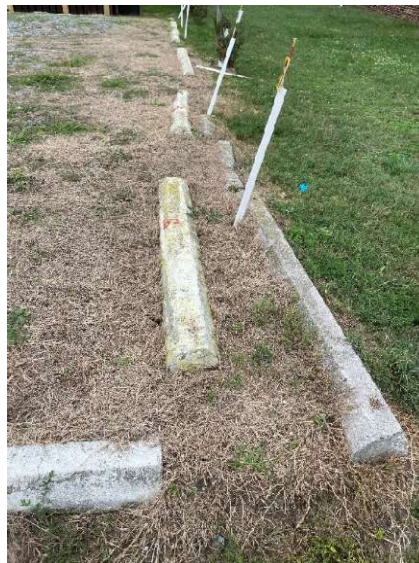
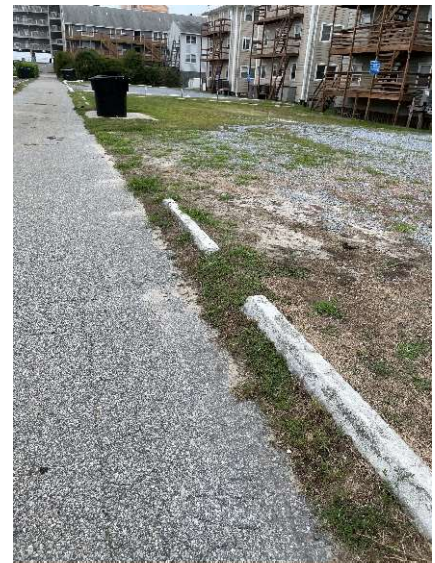
**Gravel Parking Lot & Driveway.** The Association is responsible for the parking area at the rear of the buildings and the driveway between the buildings, connecting the parking area to 139th Street. The driveway is a shared responsibility with the adjacent El Gwend East condominium. There are also off-street public parking spaces along 139<sup>th</sup> Street, in front of the buildings but these are maintained by the City, County, or other governmental entities. In general, the Association's parking area and driveway is in marginal condition.

There is vegetation encroaching into the parking area. The encroaching vegetation should be removed, and the parking area and driveway need to be refurbished by year 13. The concrete wheel stops are in poor condition and should be replaced by year 7.

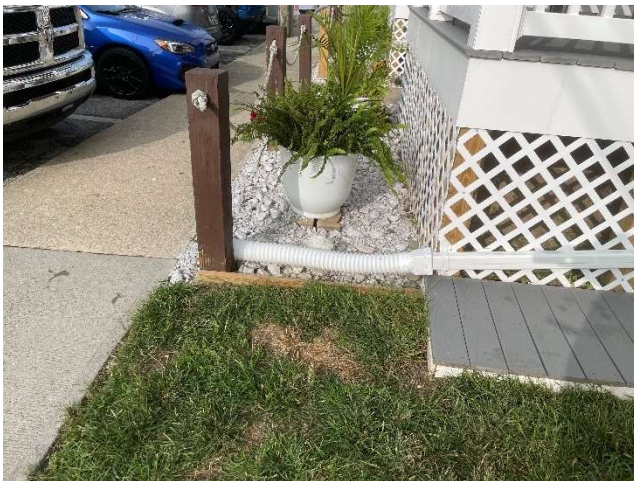
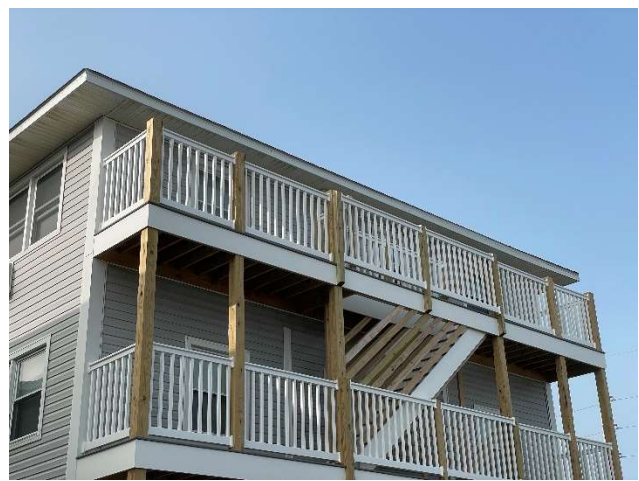
The two downspouts at the front of the building are routed to discharge directly onto the public sidewalks fronting the street. This will create a liability to the Association due to ice slicks forming on the public sidewalks creating a public hazard.

There are no gutters or downspouts along the rear edge of the roof. As a result, water drains directly onto the rear fire escapes. This will create a liability to the Association due to ice slicks forming on a means of egress and is not allowed by building codes.

A gutter and downspout system are designed to remove rainwater from the area of the building's roof, and direct water away from foundations, and protect the exterior surfaces from water damage. Ideally, gutters should be installed to run the full length of all drip edges of the building's roof.

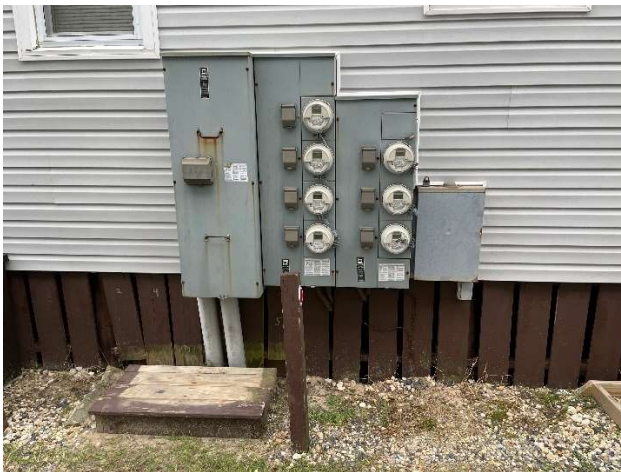
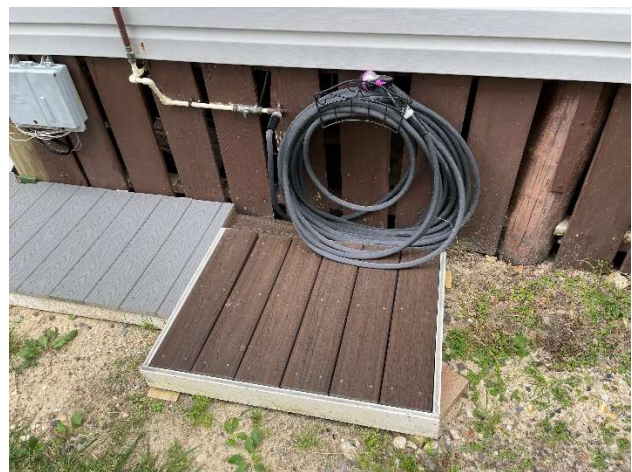
**Skirting.** There is skirting that runs vertically from the ground level outside the buildings to the bottoms of the building walls. It is constructed from 3/4" wood material, which is either attached to the retaining walls or a wood stringer, with 1" gaps between each piece. Skirting has a stained finish. The skirting is generally in good condition.

Periodic repair and re-staining of the skirting should be coordinated with the annual operating budget. When refurbishing the skirting, we recommend the Association consider using materials that are less prone to deterioration than wood in a salt air environment. As part of normal maintenance, we recommend the following:

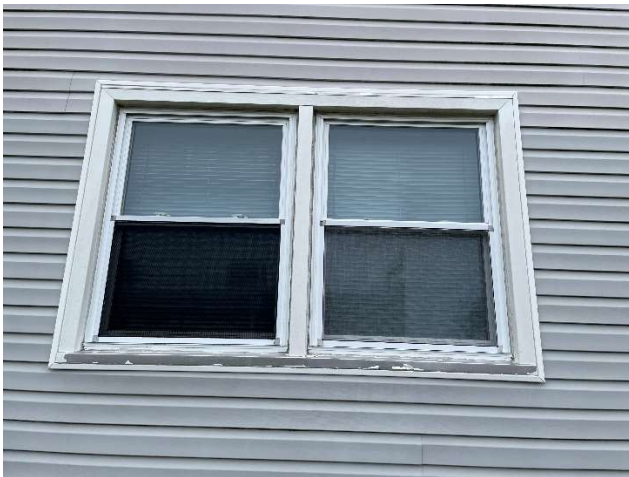
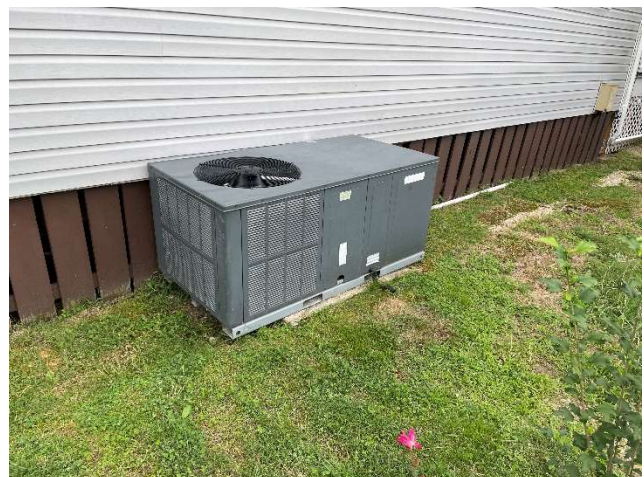
There is significant deterioration of the paint finishes on the aluminum sill trim at window frames on the west side of the building due to much higher solar exposure than the east. The caulking around the window frames will need to be replaced and is scheduled for year 7. However, the west side may need it sooner due to the much higher solar exposure.
