# REPLACEMENT RESERVE STUDY REPORT – FY 2024

## YOUR CONDOMINIUM

September 30, 2023

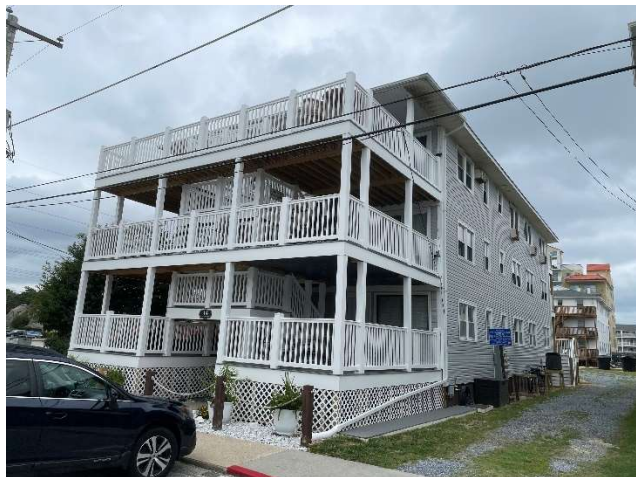
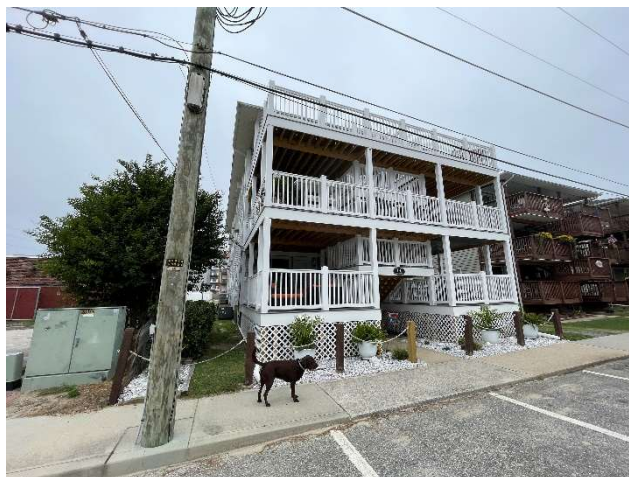
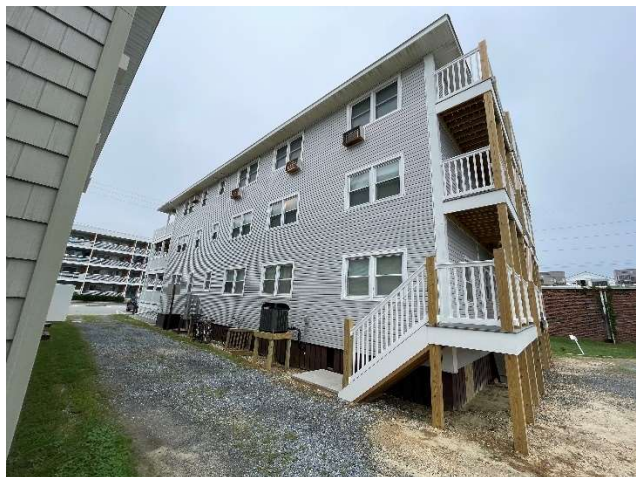
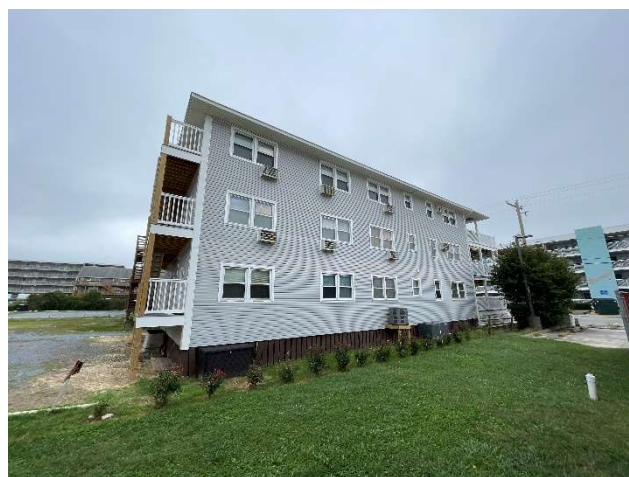
Your Condominium is in generally good condition for a residential condominium. A review of the Replacement Reserve Inventory will show that we are anticipating most of the components achieving their normal economic lives within the Study Period, except for the front porch/stairway, and rear fire escape which were replaced in 2023.

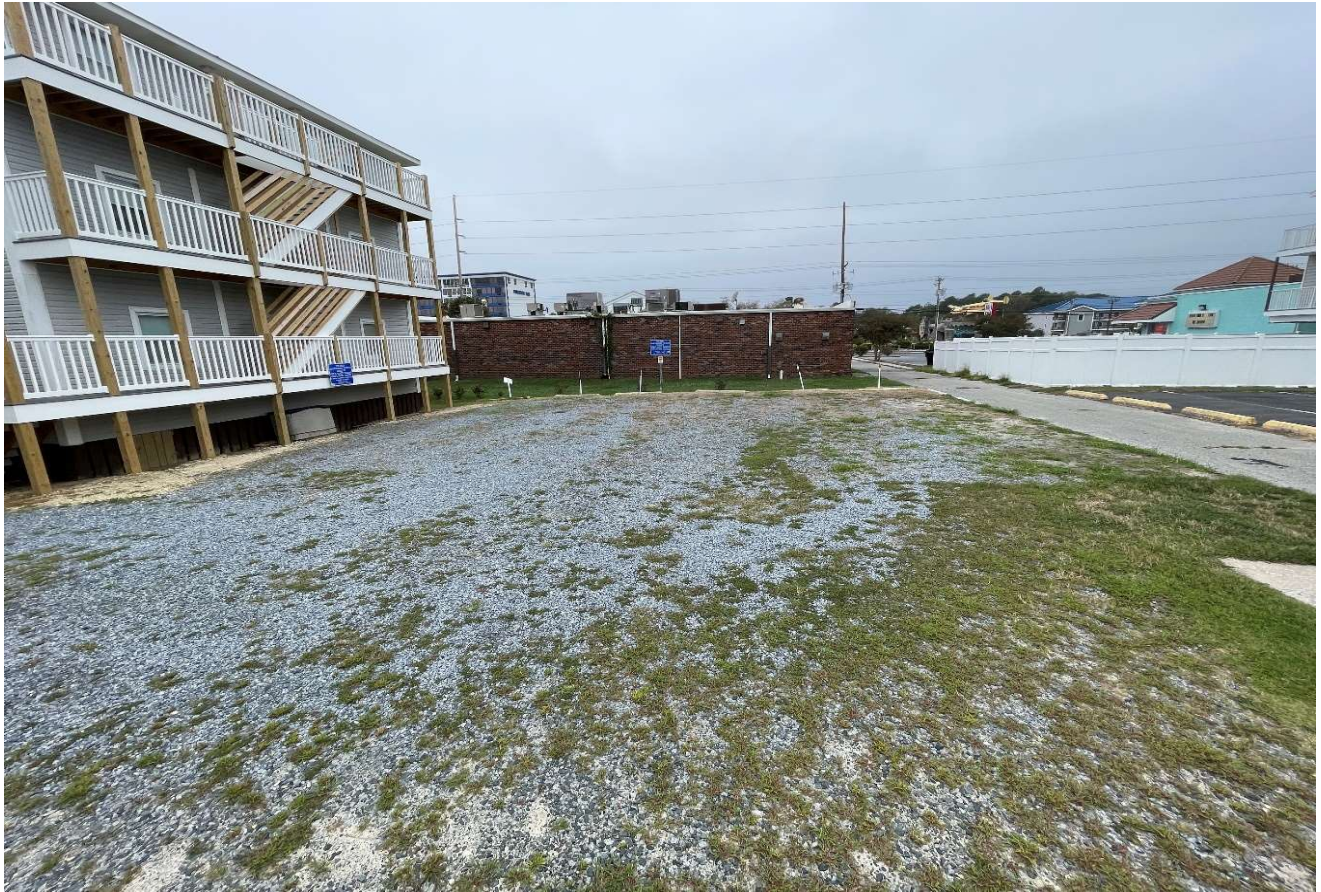
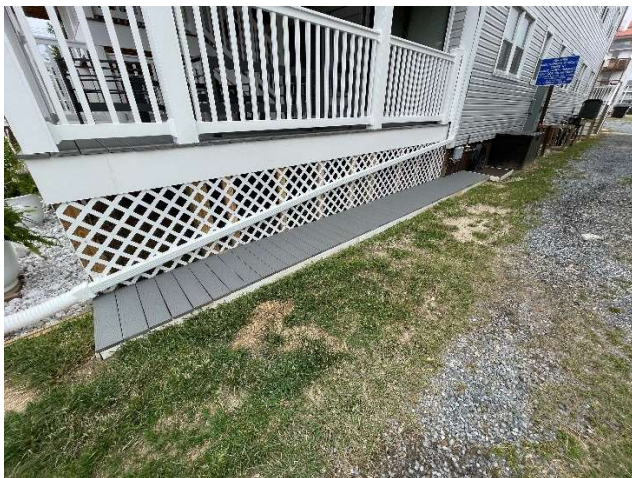
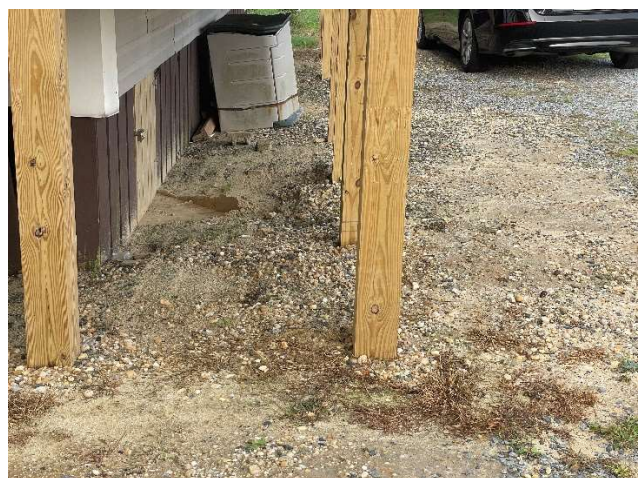
There is vegetation encroaching into the parking area. The encroaching vegetation should be removed, and the parking area and driveway need to be refurbished by year 13. The concrete wheel stops are in poor condition and should be replaced by year 7.
